**REVISED ASBESTOS AND
LEAD-BASED PAINT SURVEY
MOUNT VERNON AVENUE BRIDGE
SAN BERNARDINO, CALIFORNIA**

January 13, 2010
Project No. 205732002

Subject: Revised Asbestos and Lead-Based Paint Survey
Mount Vernon Avenue Bridge
San Bernardino, California

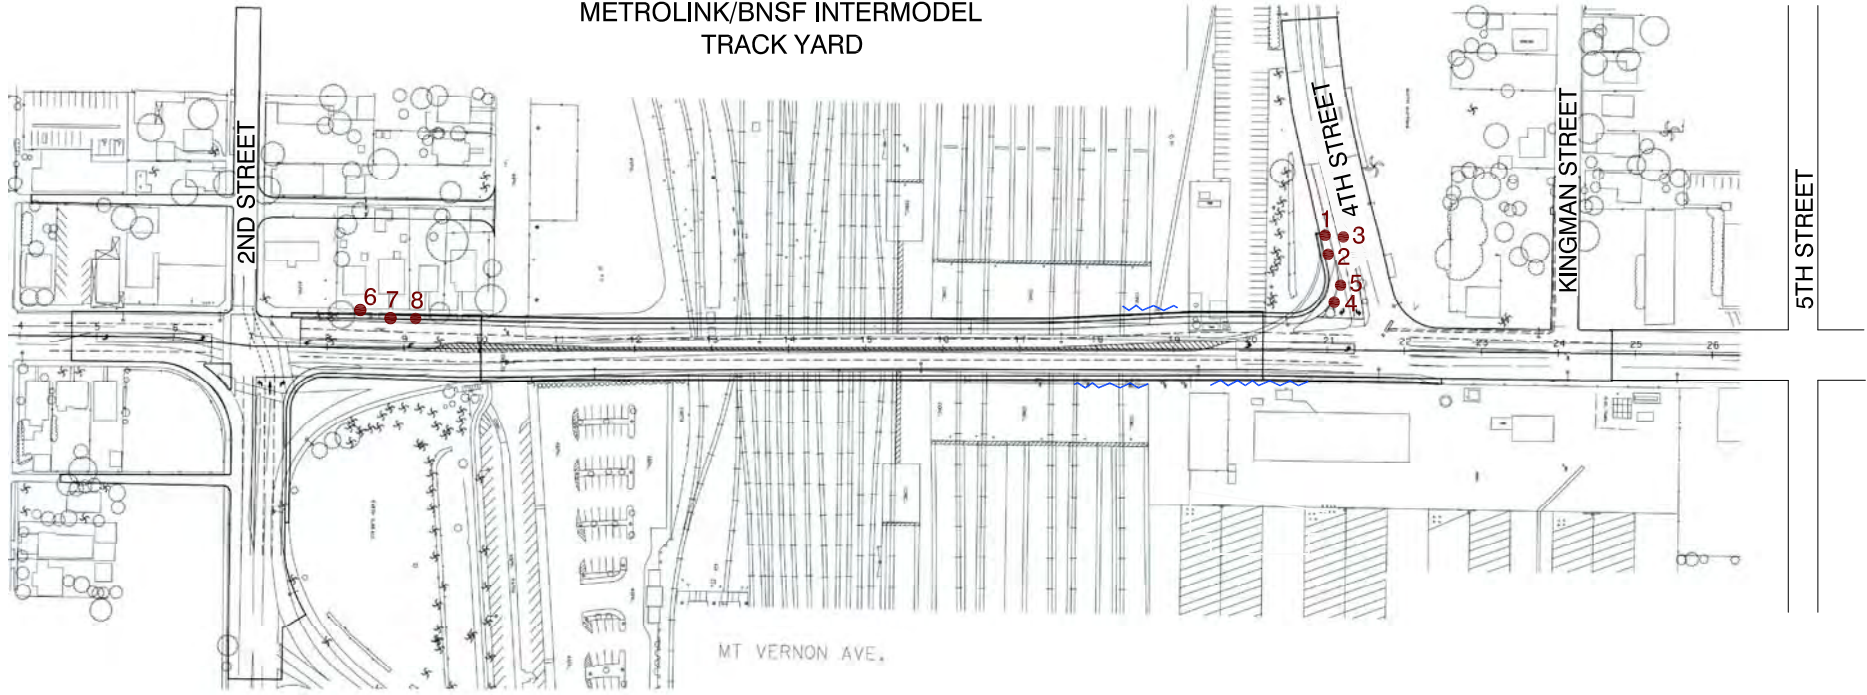
<i>Ninyo & Moore</i>		SAMPLE LOCATION MAP	FIGURE 2
PROJECT NO. 205732002	DATE 1/10

A preliminary visual assessment and bulk-sampling survey of suspect ACMs was performed. Representative samples of the suspect ACMs were collected after identification of homogeneous sampling areas (areas in which the materials are uniform in color, texture, construction or application date, and general appearance). Each homogeneous area was observed for material type, location, condition, and friability. Representative samples were collected from each area except areas that were inaccessible, or areas of assumed ACM, within the limitations of the survey. Samples were collected using EPA-recommended sampling procedures. Building materials which were sampled and analyzed for the presence of asbestos are presented in Table 1. The locations of bulk asbestos samples are shown on Figure 2.

- Approximately 100 linear feet (LF) of pipe insulation, assumed to be asbestos-containing, located on the east side of the bridge. This material was inaccessible and could not be sampled.

APPROXIMATE LOCATION OF PIPE INSULATION

- The identified ACMs should not be disturbed. Prior to renovation or demolition work which would disturb identified ACMs, a Cal OSHA-licensed certified asbestos abatement removal contractor should remove the ACMs.
