# **TECHNICAL MEMORANDUM**

DATE:	October 29, 2013
PREPARED FOR:	Mr. Todd W. Dudley / AECOM
PREPARED BY:	(Raja) S. Pirathiviraj and Lino Cheang / Earth Mechanics, Inc. (EMI)
SUBJECT:	Preliminary Foundation Report (PFR) Mt. Vernon Avenue Overhead (Replace), Bridge No. 54C-0066 City of San Bernardino, California

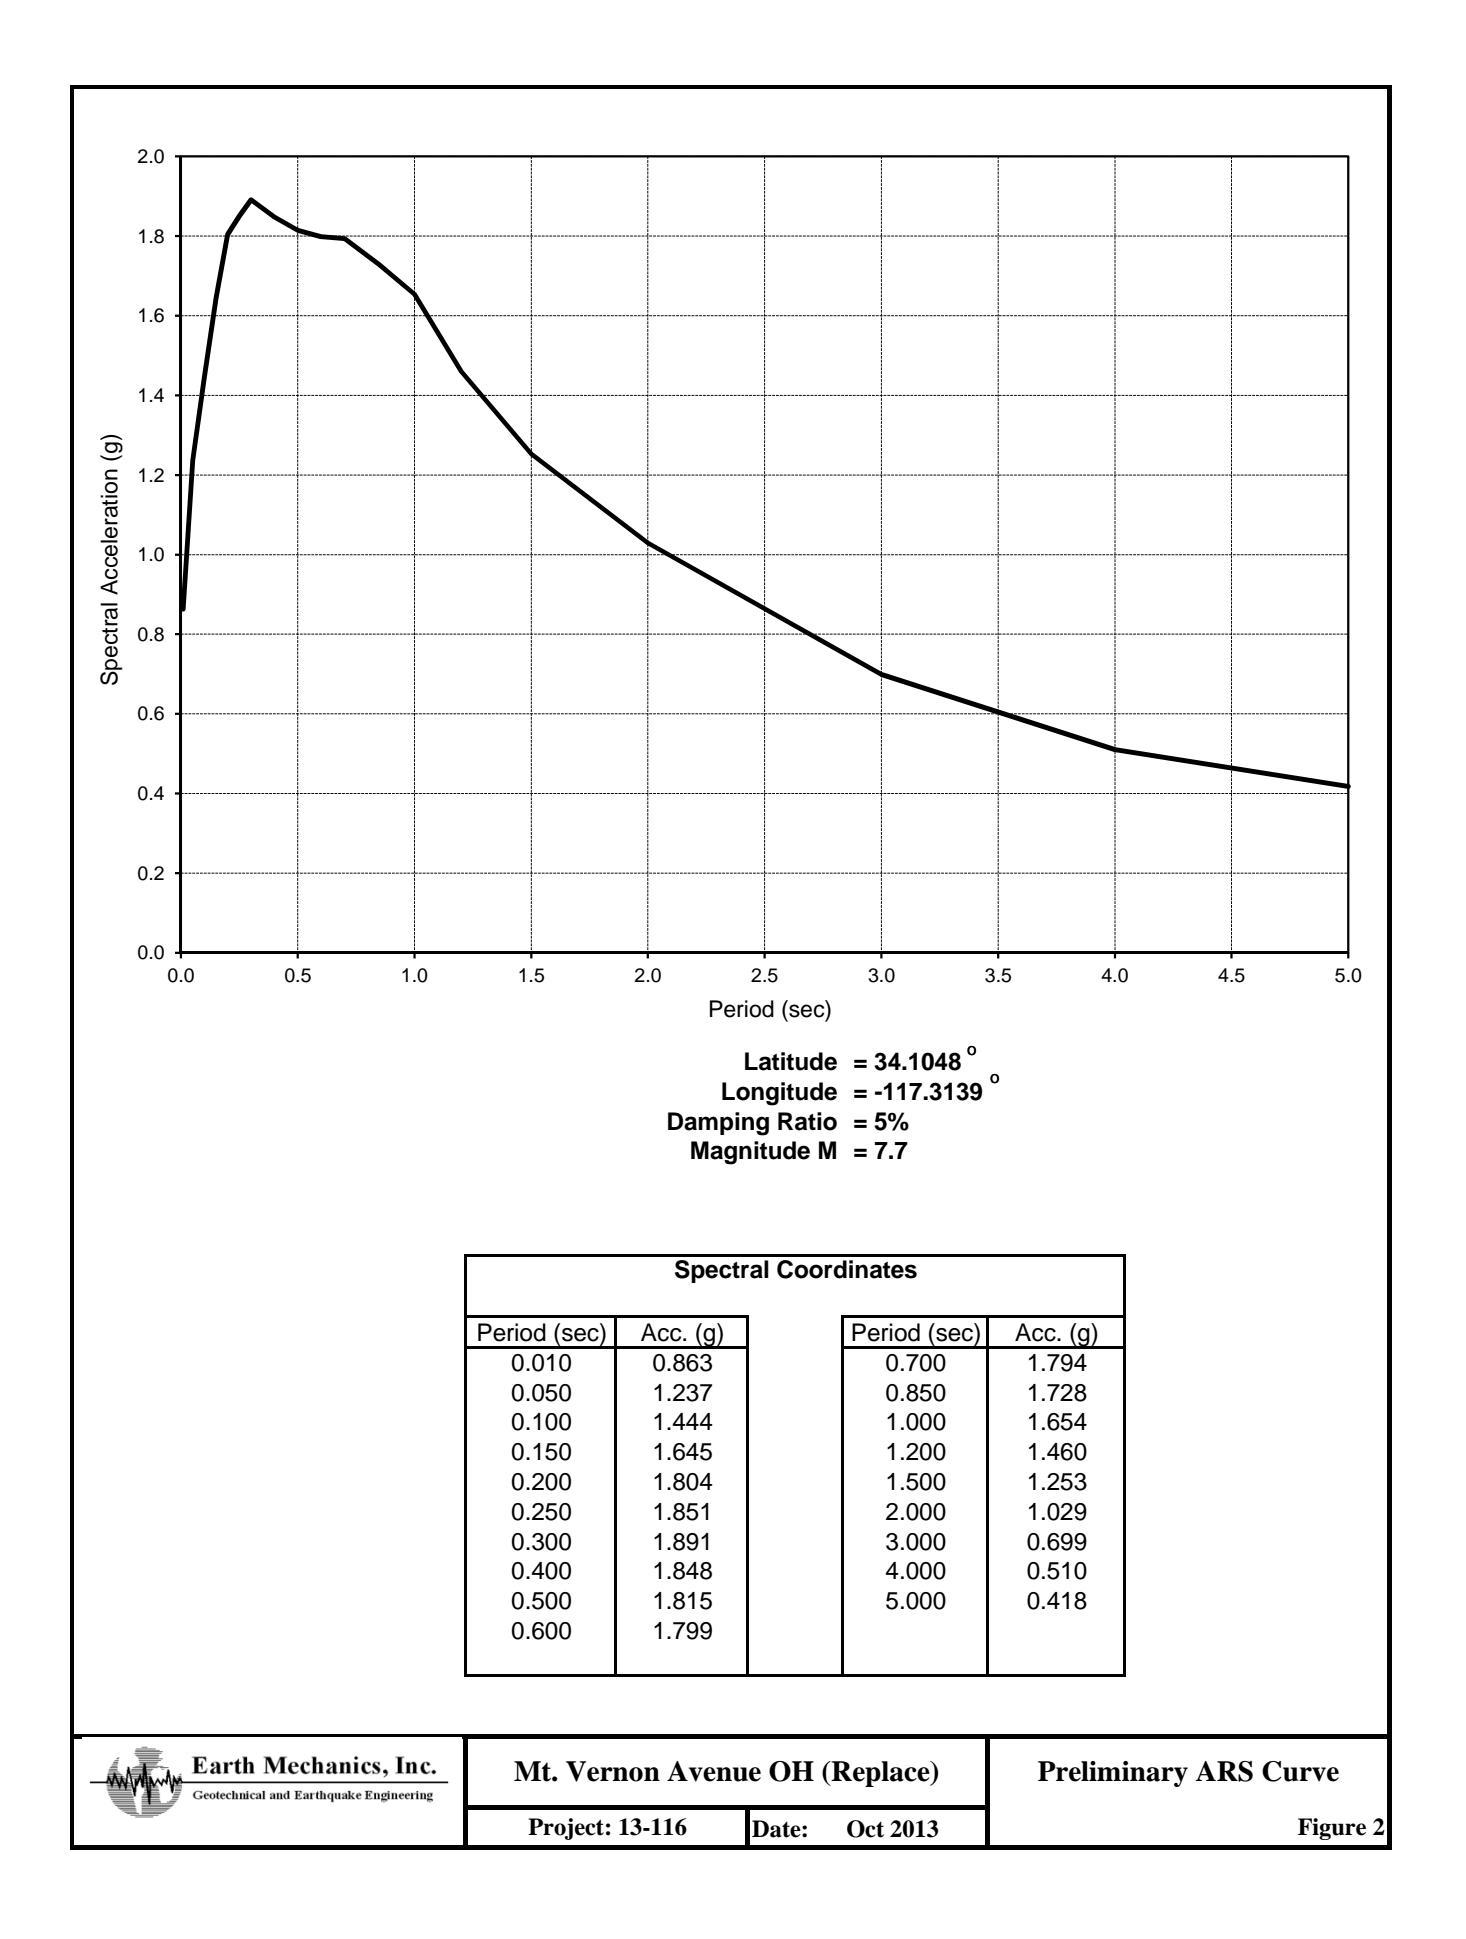
The preliminary design ARS curve was determined using the Caltrans ARS Online website. The table below summarizes the key parameters for determining the preliminary design ARS curve. The peak ground acceleration (PGA) is the zero-period spectral acceleration shown on the ARS curve. Preliminary design ARS curve is presented in Figure 2.

Site Coordinates	Latitude = $34.1037$ degrees	Longitude = $-117.3129$ degrees
Shear Wave Velocity, $V_{s(30)}$	892 feet/sec (272 m/s)	
Peak Ground Acceleration (PGA)	0.862 g

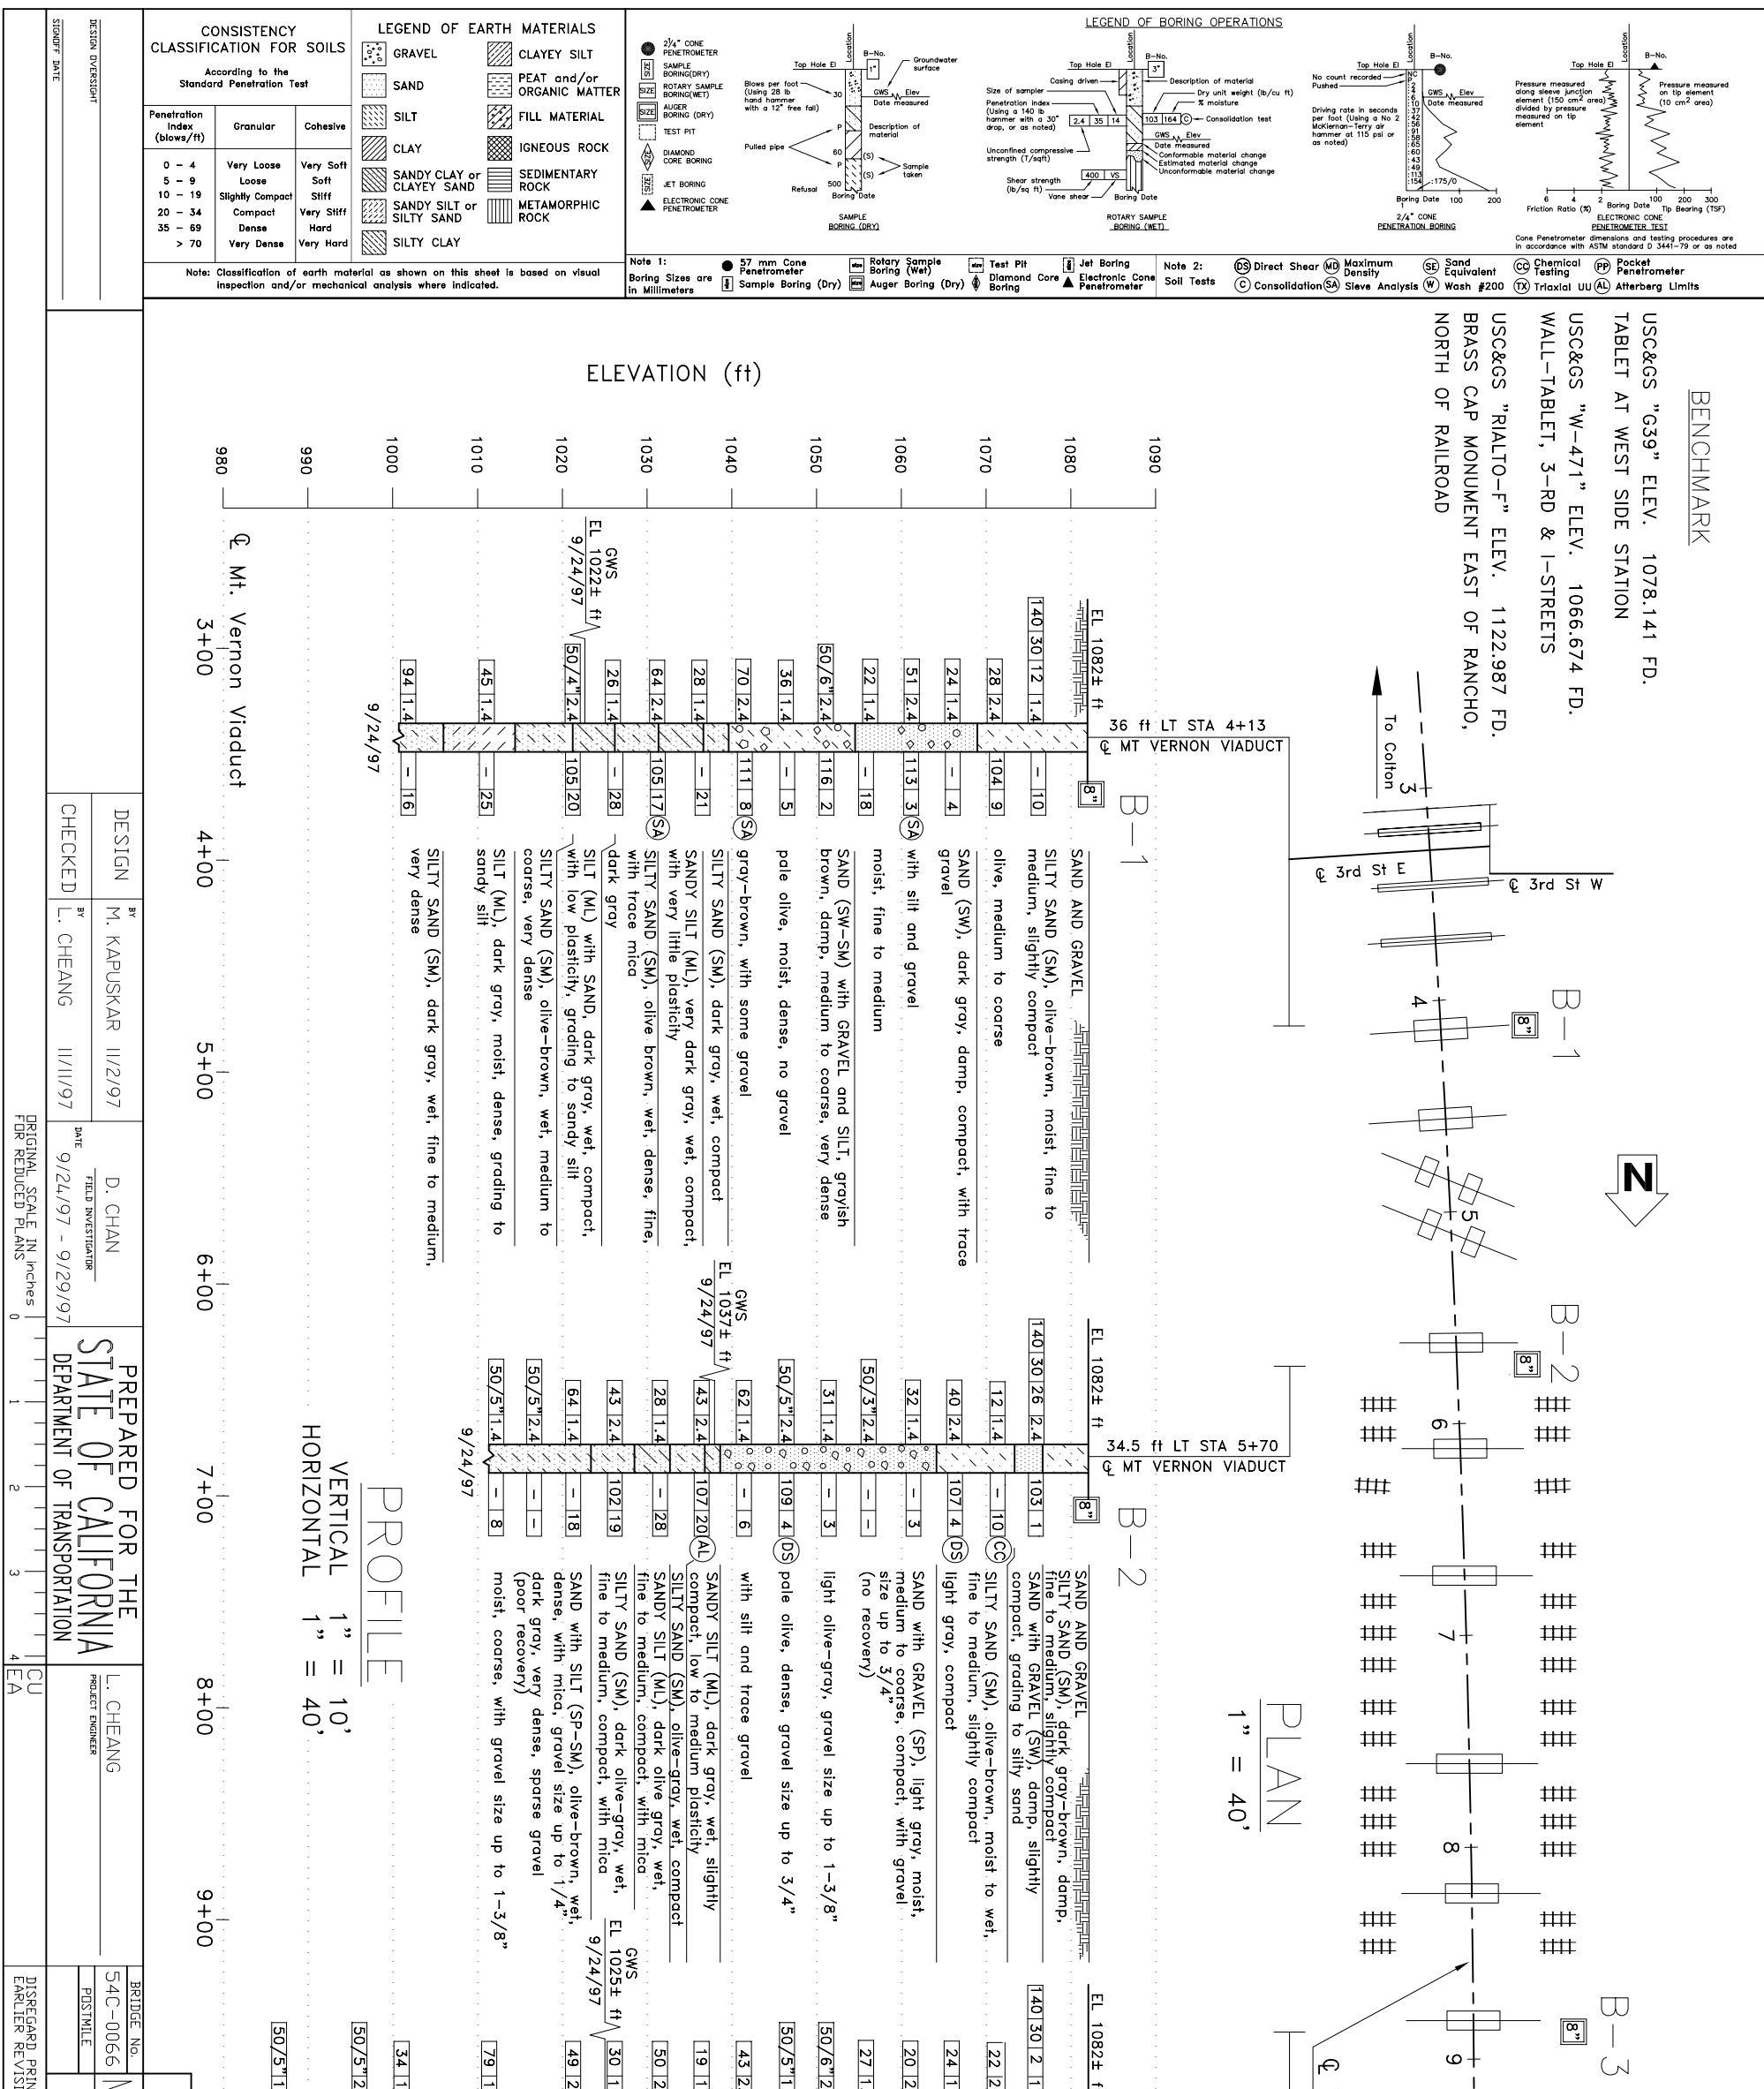
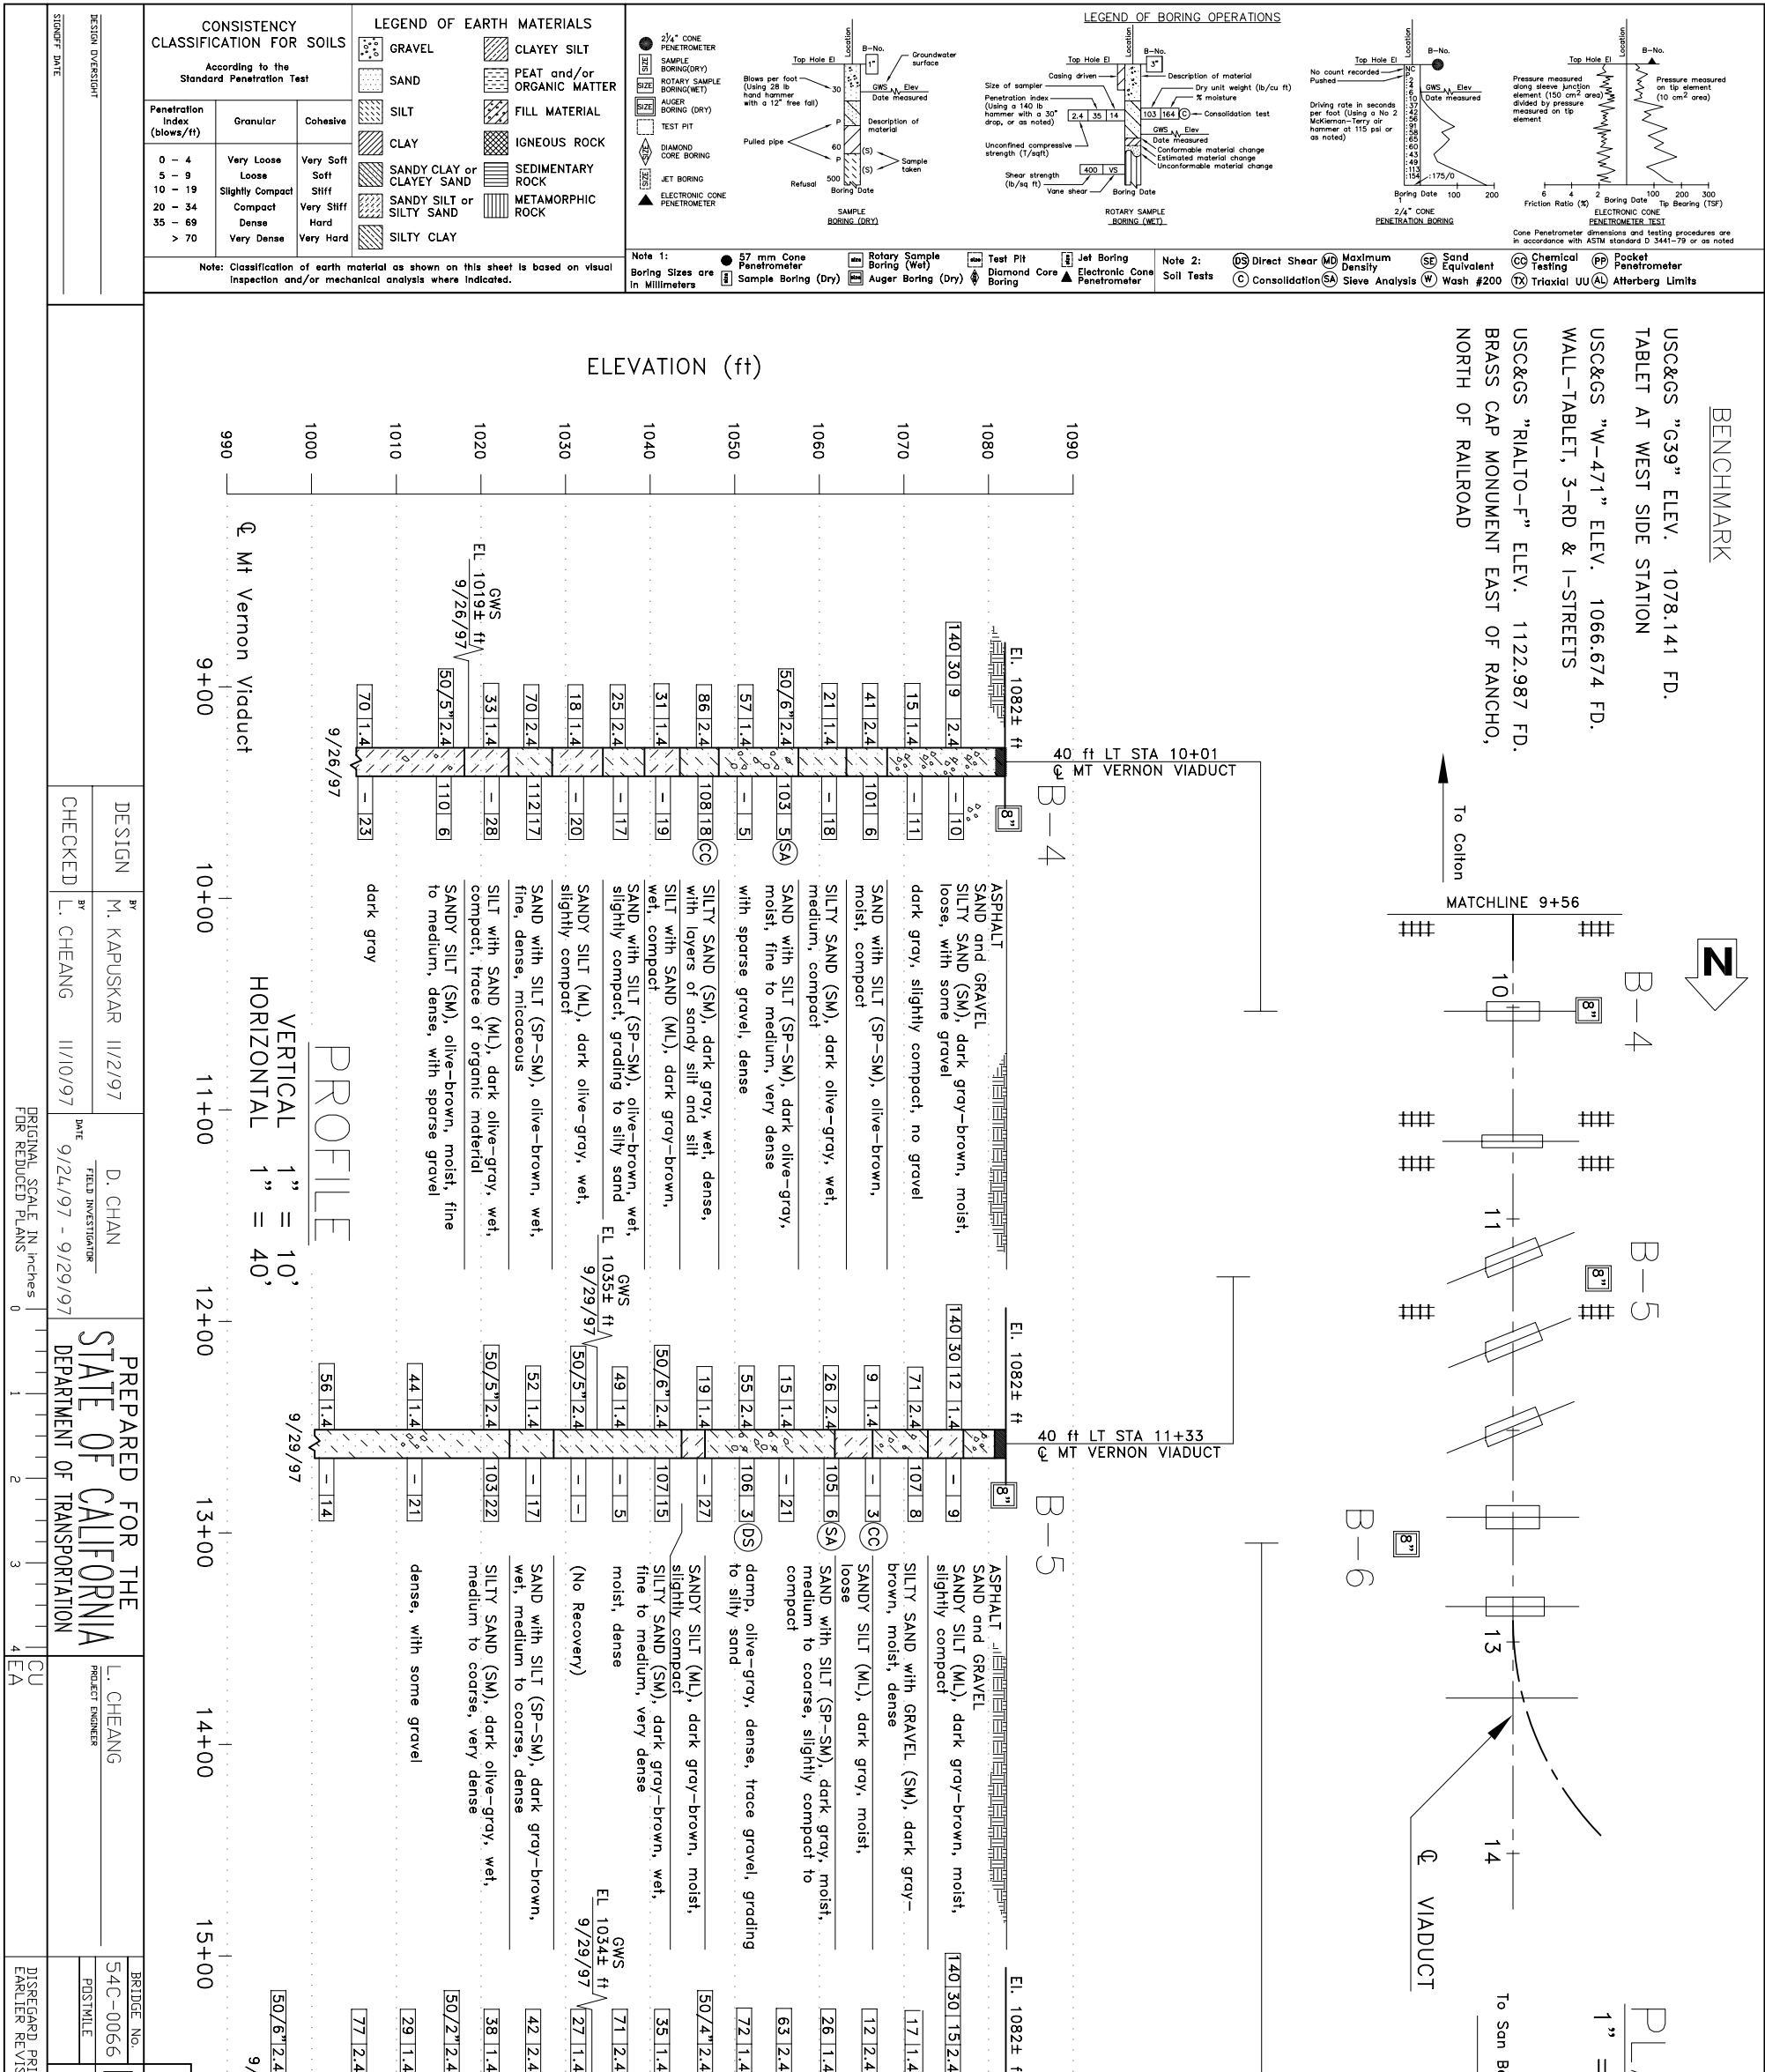
Log-Of-Test-Boring (LOTB) Sheets

<u>Subsurface Condition</u>: Elevation of the existing ground surface inside the rail facilities is about 1,082 feet. The subject site is underlain by four main soil units. The site's existing ground surface and underlying soil stratigraphy is uniform and nearly horizontal along the entire length of the bridge. As a result, a single idealized soil profile representative of the entire site was used for all abutments and bents for the purpose of foundation design. The table below summarizes the four soil units and the groundwater conditions encountered in our borings.

Unit	Top Elevation of Unit (feet)	Design Top Elevation (feet)	Soil Unit Classification			
Ι	1,082	1,082	Loose to Compact Silty Sand and Sandy Silt (SM/ML)			
II	1,054 to 1,057	1,056	Dense to Very Dense Sand with Gravel (SP)			
III	1,033 to 1,037	1,036	Stiff to Very Stiff Sandy Silt (ML)			
IV	1,018 to 1,022	1,020	Dense to Very Dense Sand and Silty Sand with Gravel (SP/SM)			
Note: Groundwater ranges from elevation 1,019 to 1,037 feet. Design groundwater is elevation 1,037 feet.

In September 1997, groundwater was encountered in four borings at depths of 45 and 63 feet below the ground surface. For design, groundwater was assumed to be at the top of Soil Unit III which is at a depth of 46 feet below the existing ground surface.

Supplemental field investigation consisting of soil borings and Standard Penetration Tests (SPT's) are on-going. Conclusions and preliminary recommendations provided in this report are based on the 1997 LOTB sheets.

Soil laboratory testing will be performed when supplemental field investigation is completed after approval of bridge type selection. Conclusions and preliminary recommendations provided in this report are based on the 1997 LOTB sheets.
