Supplemental Initial Site Assessment Revalidation

Mt. Vernon Avenue Bridge Project
Burlington Northern and Santa Fe Railroad Yard
San Bernardino, California
Federal Project Number: BRLS-6507(003)
EA: 965120

February 2018

San Bernardino County Transportation Authority
and STATE OF CALIFORNIA
Department of Transportation

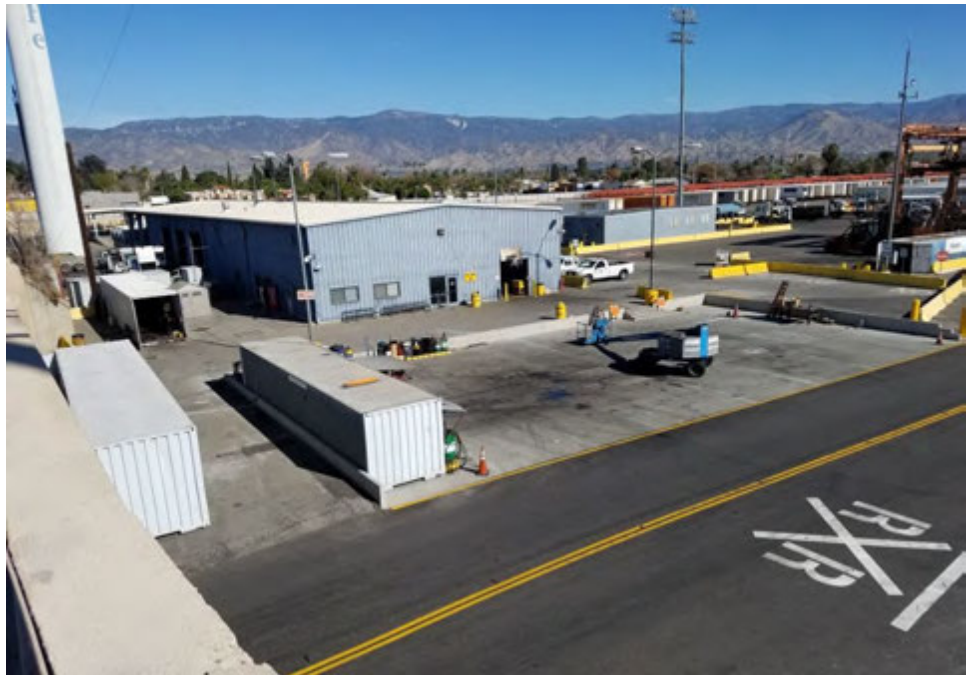
Photograph 4: Looking east at a portion of the proposed shoofly track area east of the Mt. Vernon Avenue Bridge, as well as the BNSF Office and Auto Repair Building.

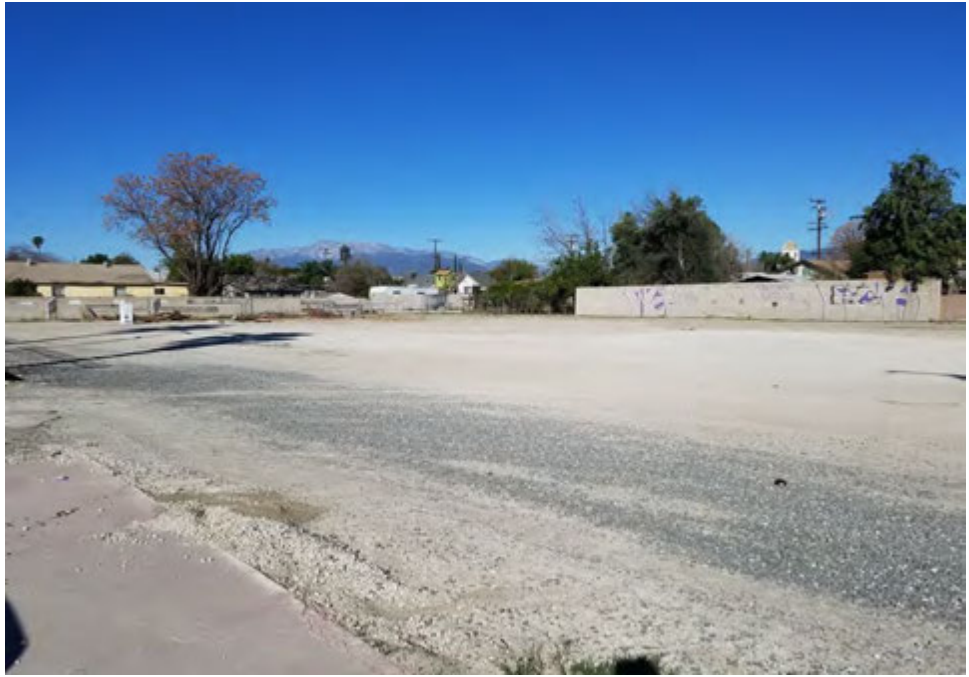
Photograph 7: View of vacant land north of West 4th Street that was previously used as a stockpile staging area.

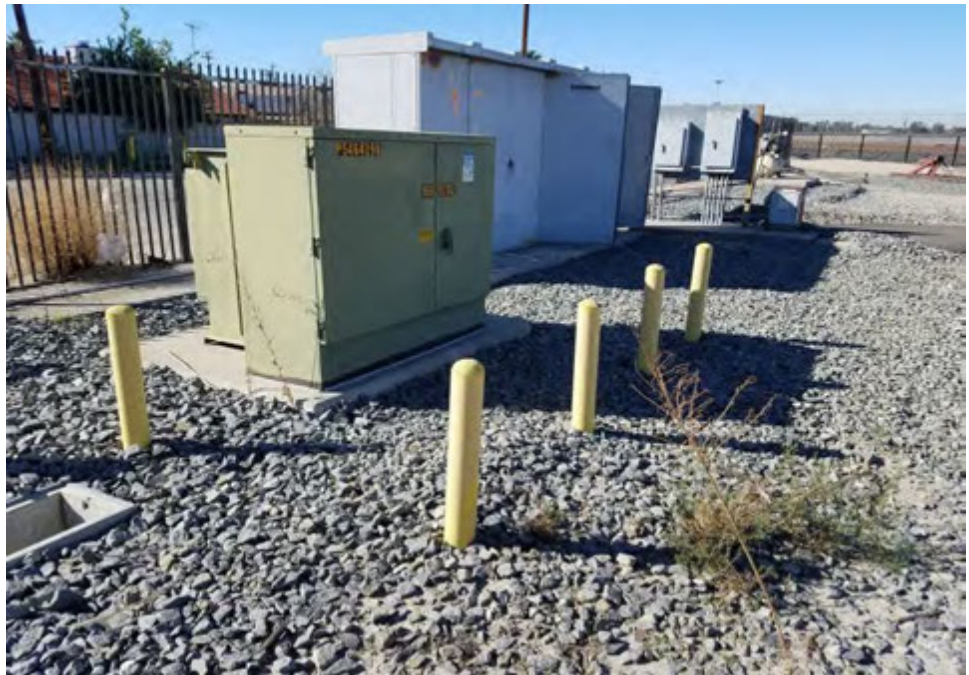
Photograph 8: View of electrical transformer and other electrical equipment at the western edge of the vacant parking lot west of the bridge.

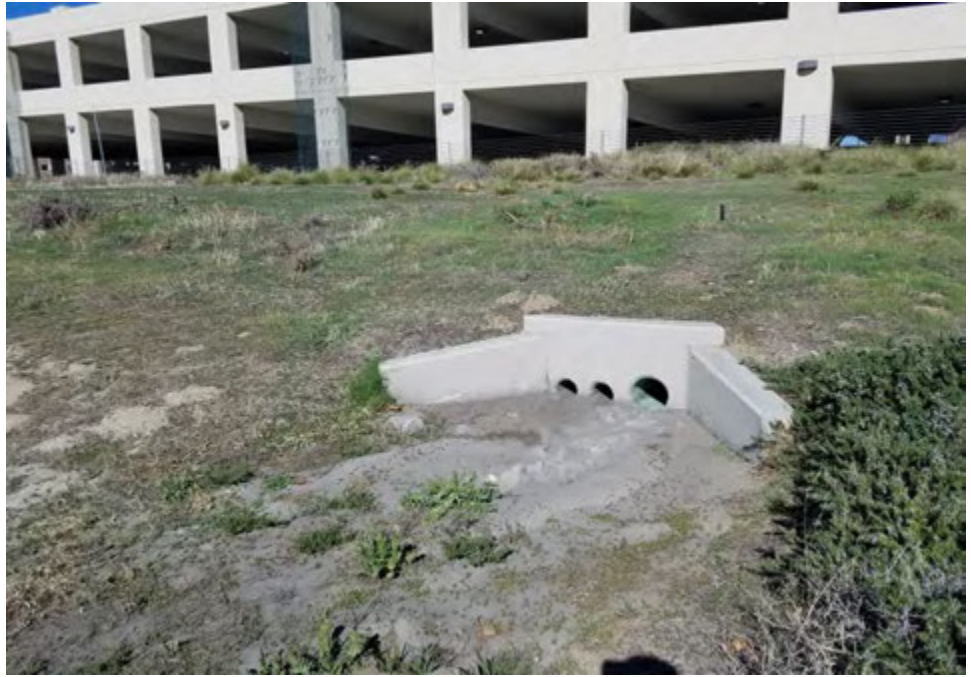
Photograph 9: View of stormwater drainage pipe that discharges to vacant land. Stormwater is likely collected from nearby parking structures.

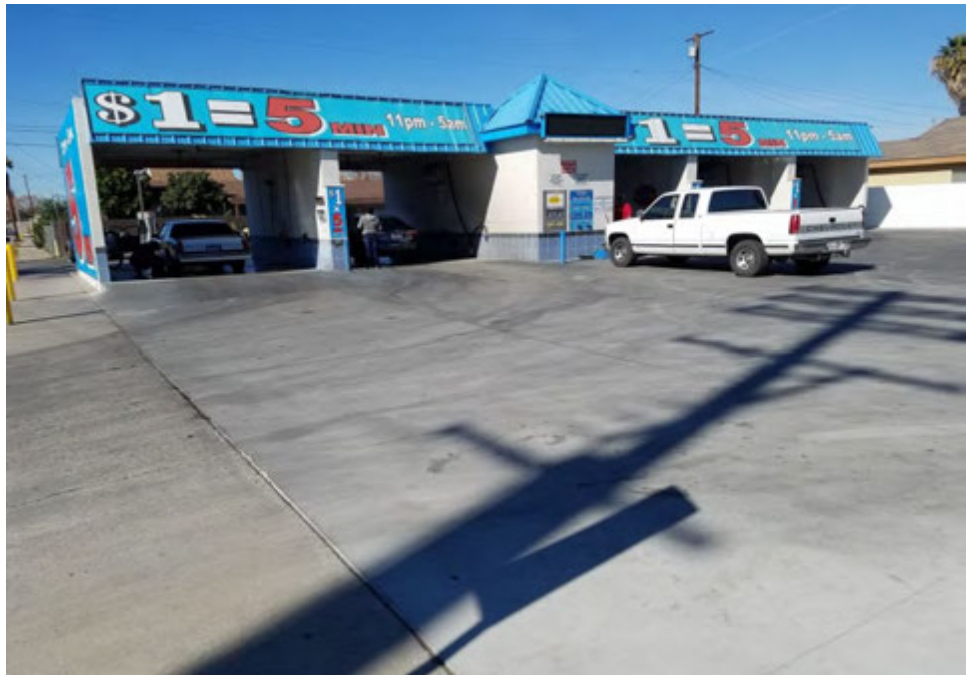
Photograph 10: View of car wash on the site at the northwest corner of the intersection of Mt. Vernon Avenue and West 2nd Street.

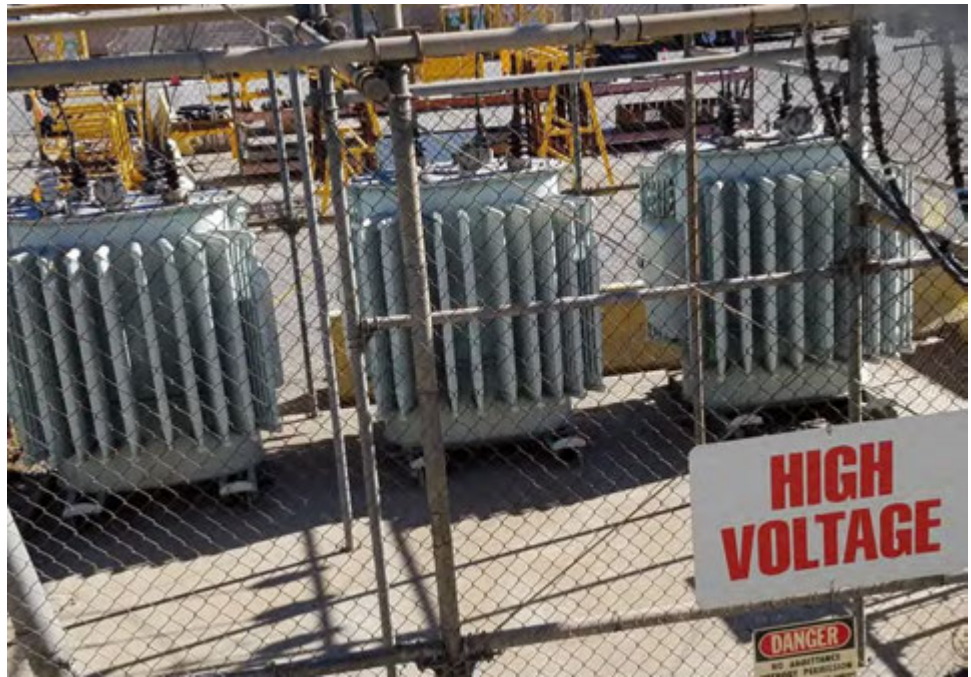
Photograph 11: View of electrical transformers at the northern portion of the BNSF Intermodal Yard on the site.

Potential PCB-Containing Equipment	X	During the site reconnaissance for the September 2017 ISA, eight pole-mounted transformers were observed around the residential neighborhood between 4 th Street and Kingsman Street. During the site reconnaissance for this ISA, pad-mounted transformers were observed in three areas of the site: one at the southwest corner of the vacant lot west of Mt. Vernon Avenue and north of 3 rd Street; one at the parking structure east and adjoining Mt. Vernon Avenue; and three transformers at the northern end of the BNSF Intermodal Facility. Staining, discoloration, or other signs of release of PCBs was not observed around the transformers. The locations of transformers are depicted in Figure 2.
Chemical/Petroleum Odors		Not observed
Concrete Patches/Pads		Not observed
Pools of Liquid		Not observed

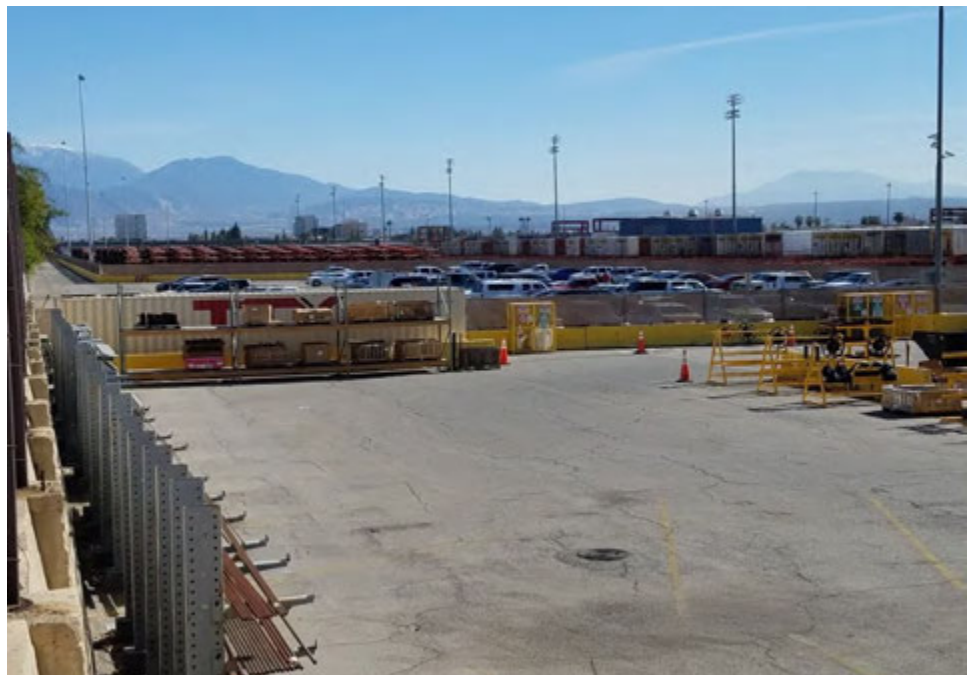
Photograph 12: View of the northern portion of the BNSF Intermodal Yard that consists of miscellaneous storage of compressed gases, crates, tracks, and a parking lot.

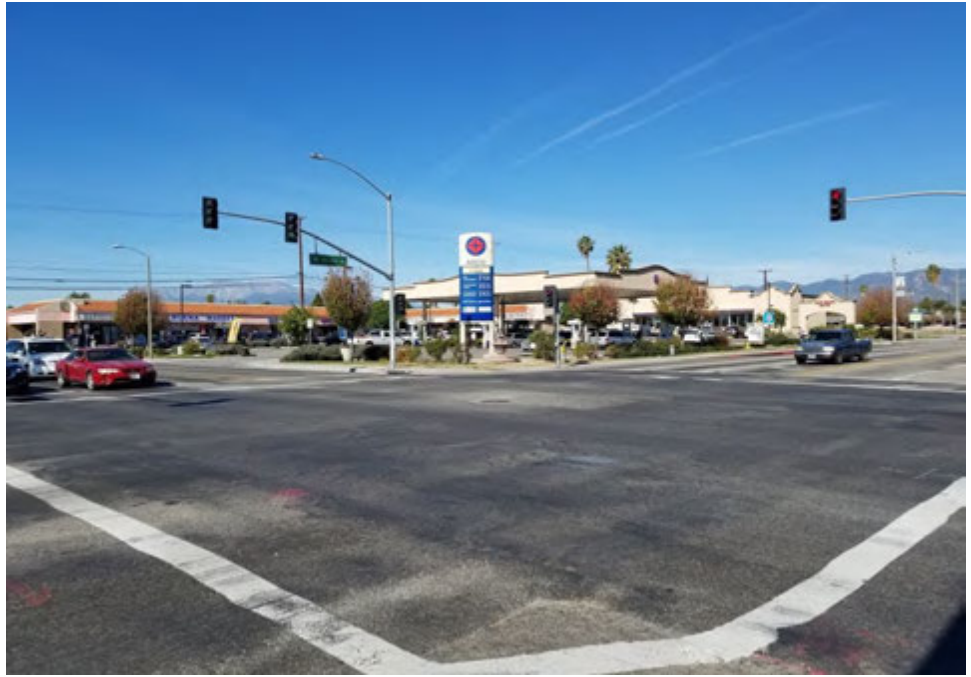
Photograph 13: Looking north away from site at the intersection of Mt. Vernon Avenue and West 5th Street. The Arco gasoline station is present at the northwest corner of the intersection.

Waste Generation/Storage/Disposal	X	During the site reconnaissance for this ISA, five ASTs (approximately 250-gallons each) containing oil were observed in the vehicle maintenance area east of the bridge and north of the shoofly, depicted in Figure 2. During the site reconnaissance for the January 2018 FISA, hazardous waste materials observed included a 185-gallon AST containing used motor oil and several 55-gallon drums as described above. In addition, five 55-gallon drums containing non-RCRA hazardous waste were observed north of the hazardous material storage area. The accumulation date on the drums was November 18, 2017.
ASTs	X	Eighteen ASTs were observed on BNSF property north of the shoofly and east and west of the bridge, as described above.
Potential Evidence of USTs		USTs were not observed on-site. However, evidence of USTs were observed at the Arco gasoline station adjoining to the northwest of the site.
